RE: Glenwood Middle School Trailer #20, Mold Investigation

On October 4, 2017 a representative from Soil and Land Use Technology, Inc. (SaLUT) conducted a mold investigation in Trailer #20 at the Glenwood Middle School, a property maintained by the Howard County Public School System (HCPSS), located at 2690 MD-97, Glenwood, MD 21738. Mr. Herbert Savje, Director of School Facilities, accompanied the representative from SaLUT to view the area of concern.

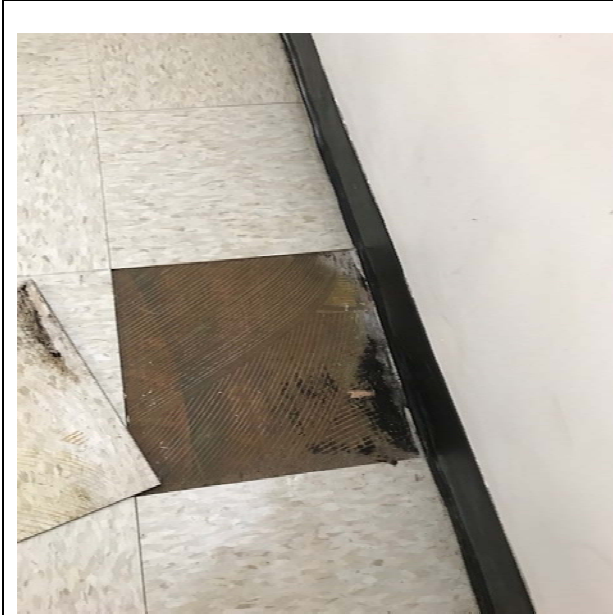
Trailer #20 Below the 1st window from the entrance

Mold was detected in the swab samples from underneath the floor tiles in affected area.

- Removal of affected floor tiles and flooring components, mold abatement, and replacement.
